FINAL REPORT REMEDIAL INVESTIGATION

WAREHOUSE AREA WASTE PILE

CAMP NAVAJO BELLEMONT, ARIZONA

July 1999

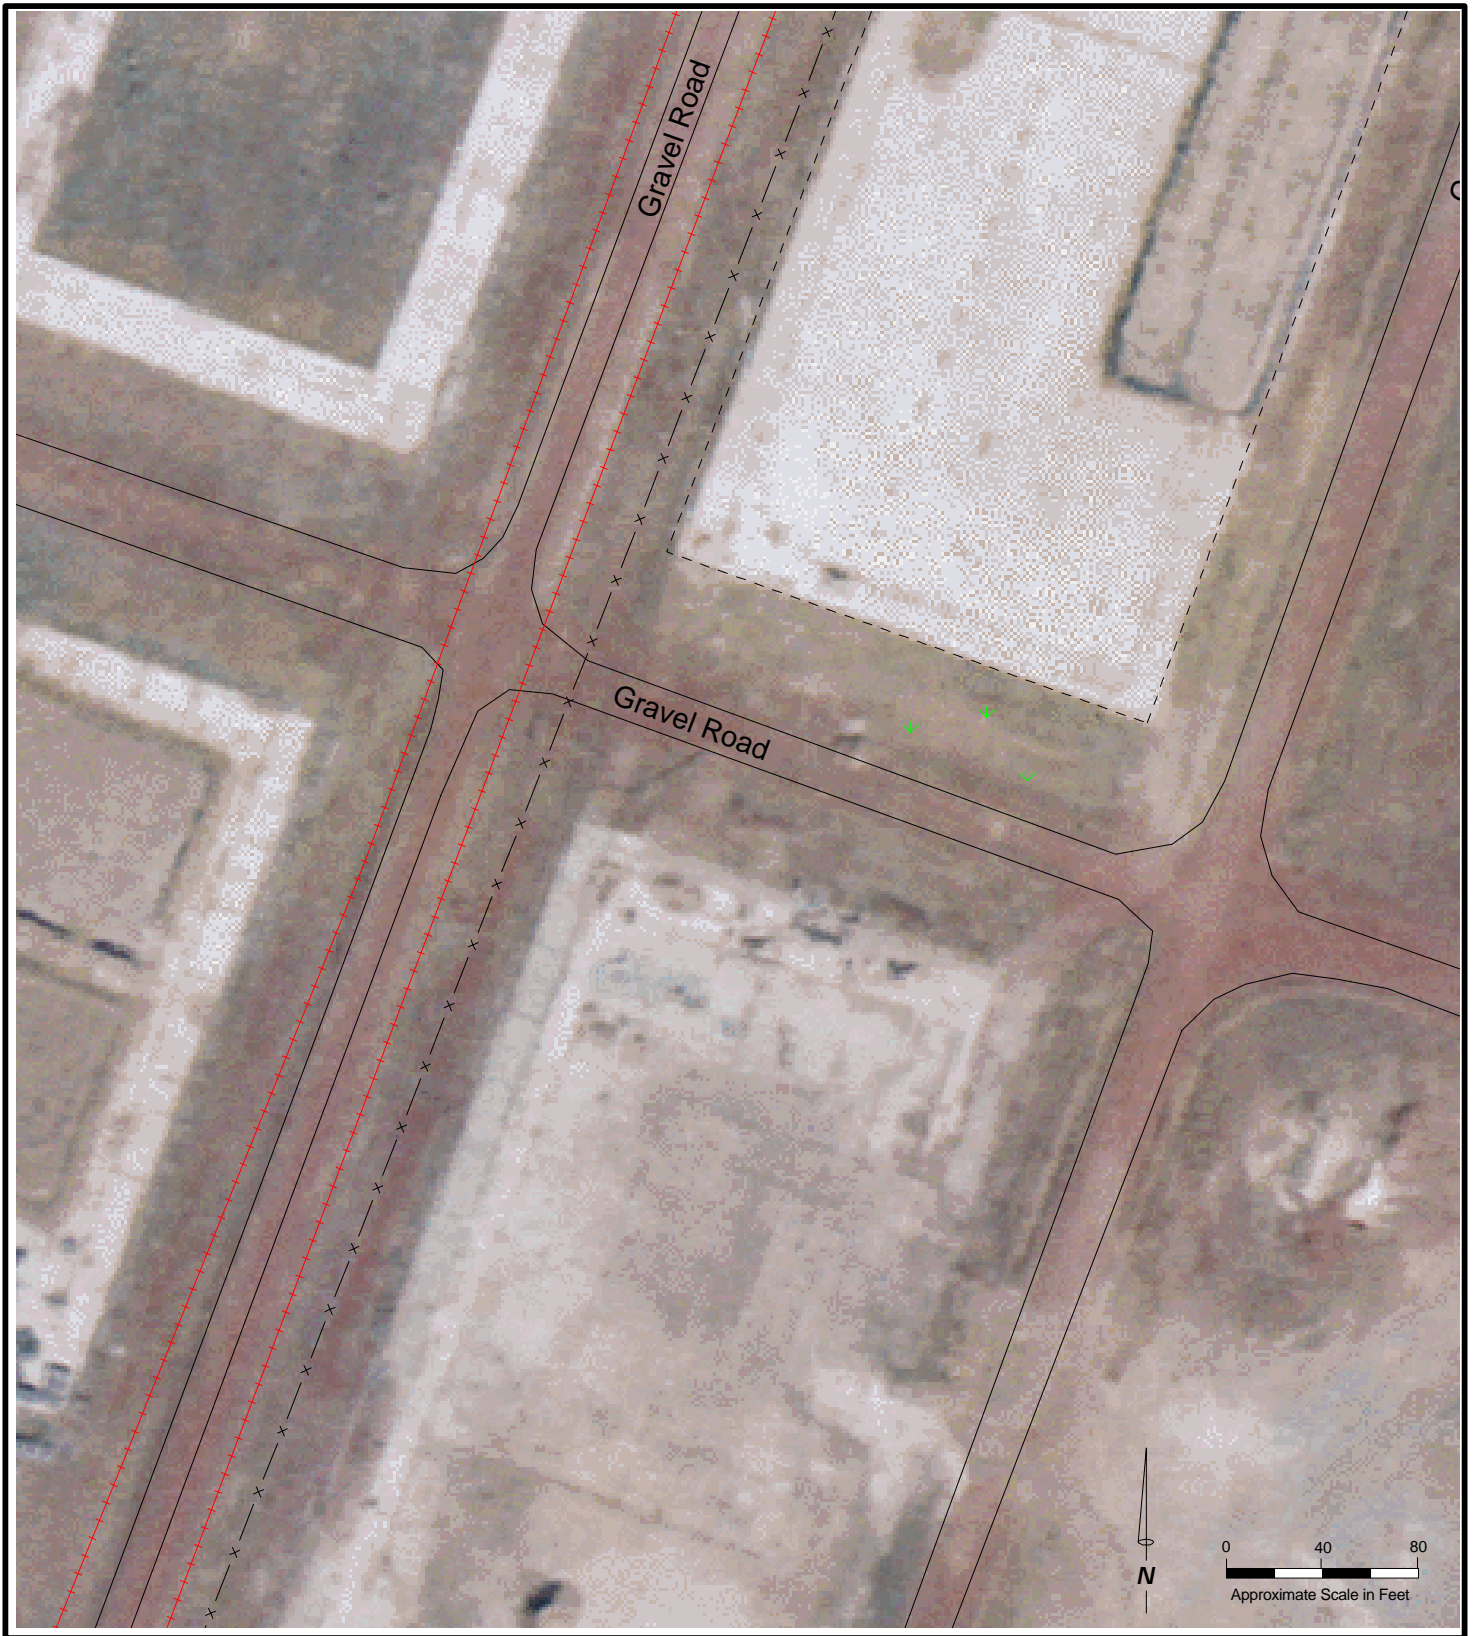
Figure 1-2

Warehouse Area Waste Pile

Site Plan

The warehouse area waste pile (Figure 1-2) east of the GSA warehouses (Figure 1-3) was situated partially on the concrete pad of former Building 233 and partially on the adjacent ground surface (USAEHA 1987). The 70 by 160-foot pile was removed to an off-site landfill at the time of the Argonne National Laboratory (ANL) site visit in 1990.
